Original Article

# Effect of fiber placement on the fracture resistance of moderate-size MOD cavities in maxillary premolars: An in vitro study

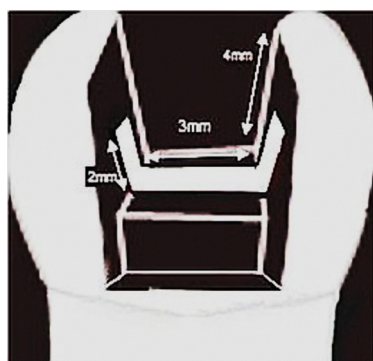
Figure 1. Schematic representation of cavity size and fiber placement

previously wetted in resin (Margin Bond) for 5 minutes, was placed buccolingually in the pulpal floor of the cavity, extending 2 mm onto the buccal and palatal walls. This fiber was approximately 7 mm in length (Figure 1). Another thin layer of flowable composite resin was then applied over the fibers, and all three layers were cured for 40 seconds. The cavity restoration followed the same procedure as in group 2.

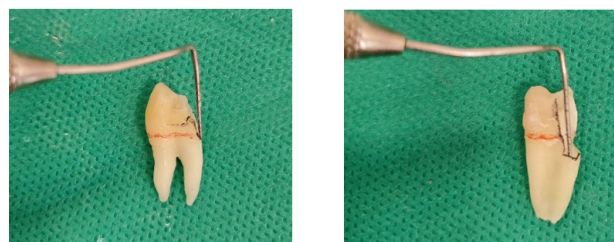
1. View of favorable fracture.

2. View of unfavorable fracture.

Figure 2. The type of fracture included favorable and unfavorable teeth

In this group, the buccal and palatal walls were reduced by 2 mm, and the restorative procedures were conducted similar to those in group 2. All the samples were stored in an incubator (Behdad, Iran) for 24 hours at 37 °C in distilled water and subjected to thermocycling (500 cycles at 5– 55°C) (Vafaei Industrial, Iran). To simulate the periodontal ligament, the roots of the teeth were embedded in melted wax below the CEJ to leave a thin layer, 0.2–0.3 mm in thickness, around the root. The samples were then embedded in self-curing acrylic resin (Acropars, Iran) up to 2 mm below the CEJ, using a cylindrical mold while ensuring that the tooth's long axis remained perpendicular to the surface. After observing the first signs of polymerization, the teeth were removed from the resin block and repositioned, and the wax was removed. Light-body silicone impression material (Speedex) was injected into an acrylic block with the teeth reinserted, forming a uniform silicone layer around the roots. All the samples underwent mechanical load cycling using a chewing simulator (SD Mechatronic, Germany), which applied 100,000 cycles under a 30-N load at 1.7-Hz frequency via a 4-mm stainless steel sphere positioned vertically on the occlusal surface. Afterward, the samples were placed in a universal testing machine (Rochdale, England) to perform the fracture resistance test. The constant compressive load was applied using a 4-mm stainless steel sphere at a crosshead speed of 0.5 mm/min,<sup>9</sup> aligned parallel to the longitudinal axis of the tooth and contacting the slope of the cusps. The load was applied until fracture occurred. Maximum load values (Newtons) at fracture moments were recorded, and the fractured tooth pieces were evaluated for fracture type, categorized as favorable (less than 1 mm below CEJ) or unfavorable (>1 mm below CEJ) using magnification

and assessed by two calibrated operators (Figure 2). The results were analyzed using SPSS 25.0 to compare fracture resistance values with one-way ANOVA and Tukey tests, while fracture type comparison used chi-squared and Kruskal-Wallis tests. A significance level of  $P < 0.05$  was established. Normality of the data was assessed using the Kolmogorov-Smirnov test.

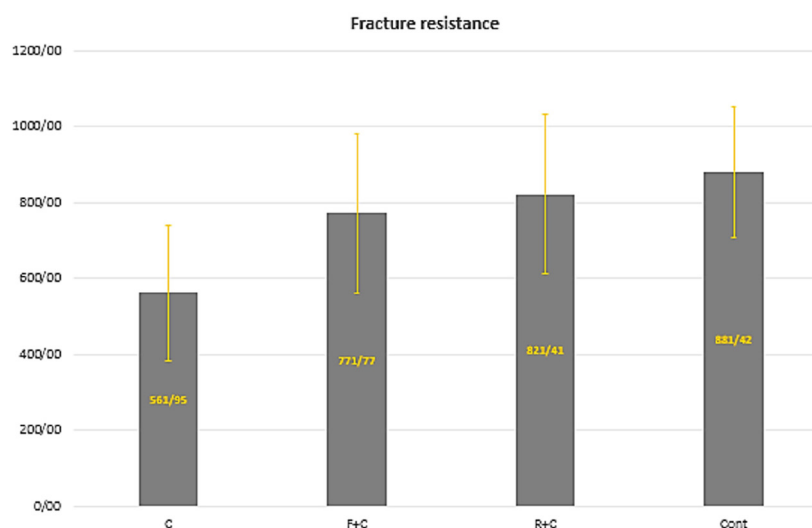
**Figure 3.** Means and standard deviations of the fracture resistance of composite resin restorations in different methods in the study groups

The mean fracture resistance of the samples is shown in Figure 3. The maximum fracture resistance was observed in the control group (881.42 N), while the lowest was recorded in the conventional composite resin restoration group (561.94 N) (Table 4). The difference in fracture resistance values between the experimental groups was significant ( $P = 0.002$ ). Additionally, the differences between the conventional composite resins and both the control and cusp coverage groups were significant (Table 5).

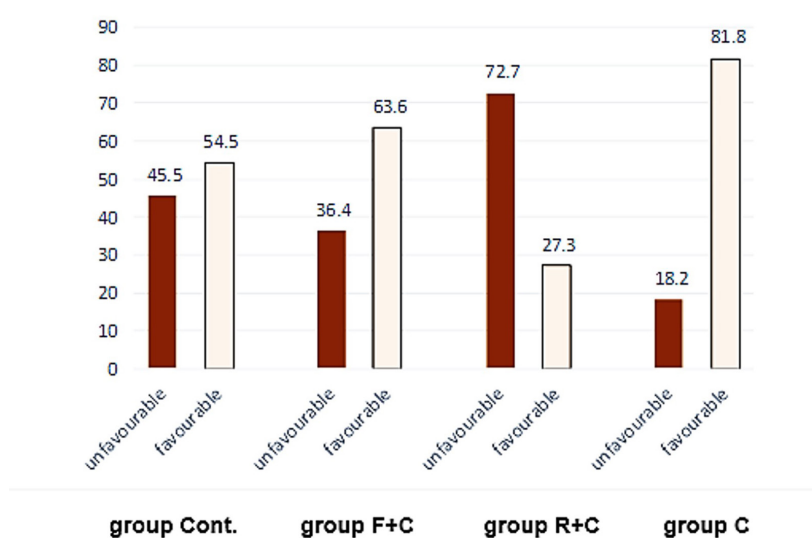
**Figure 4.** Frequency percentages of unfavorable and favorable fractures in composite resin restoration in different methods in the study groups

Figure 4 presents the frequency of favorable and unfavorable fractures in the groups. Based on the chi-squared test, the difference was marginally significant ( $P = 0.09$ ). Notably, the difference between the cusp coverage group and the composite resin-fiber group was significant.
