# Effects of Three Different Niti Rotary Instruments on Dentin Cracks After Root Canal Preparation

**Introduction:** This study aimed to examine the effects of three distinct nickel–titanium (NiTi) rotary instruments on dentin crack formation during root canal preparation in various root segments.

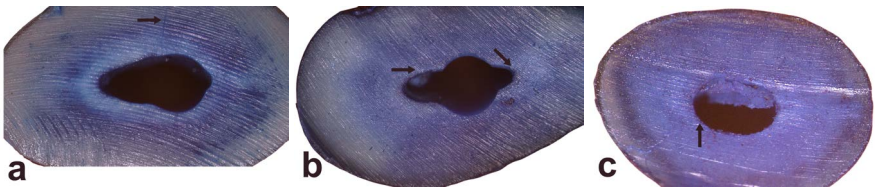
Figure 2. A stereomicroscopic image of three segments: a) coronal third, b) middle third, and c) apical third. The arrow indicated a crack line

thirds (Table 2). Most dentin cracks were found in the coronal third, whereas the least ones were in the middle third of the root canal wall (Figure 2). Table 3 shows differences in dentin crack formation across material types and rotational speeds.
